Ladybower Reservoir

Concrete Pier Refurbishment

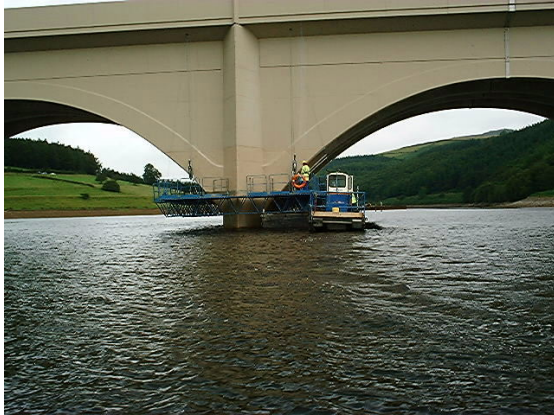
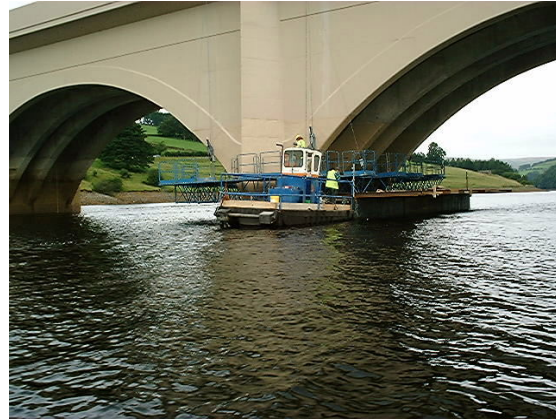
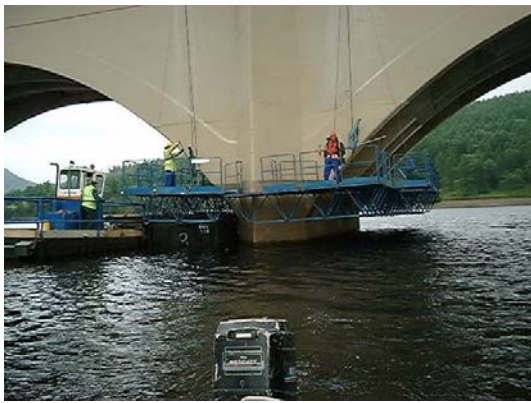
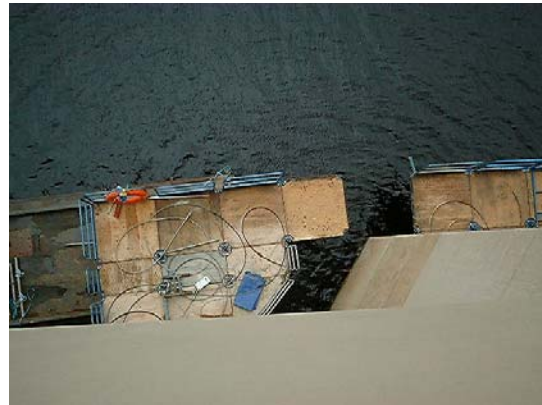
The problem of how to access all Ashopton Bridge piers was overcome by the design, supply and installation of a special truss frame suspended access platform. In order to carry out concrete repairs ALPS supplied the custom suspended access platform that was assembled on the shore and transported in two halves to the pier locations.

With only four small holes cored into the bridges footpath above each pier four pairs of 16mm steel suspension and safety ropes were lowered through and the platform mounted hoists and safety devices were attached.

The platform was raised and joined together to form a wrap-around heavy-duty working platform that could be raised and lowered to keep the platform floor level with the water-line as the dam water was lowered to enable progressive repairs. With the job completed the platform was quickly removed and the core holes were filled in leaving no signs of maintenance activity on the bridge.
